Seaman Corporation

Improved Polyurethane Storage Tank Performance

Contract No. SP0600-04-D-5442, Delivery Order 1029

FY2009 Final Technical Report

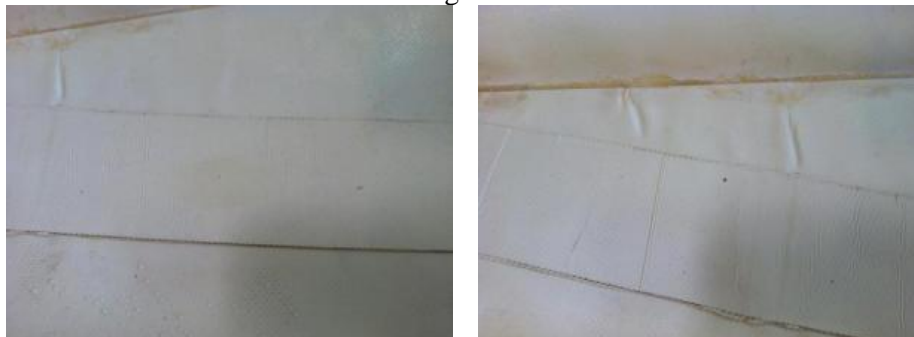
Figure 5.4.104 – Class I – T14-8 – Closing Seam leak – 12 JUL 13
Double butt seam gaps internal (right)

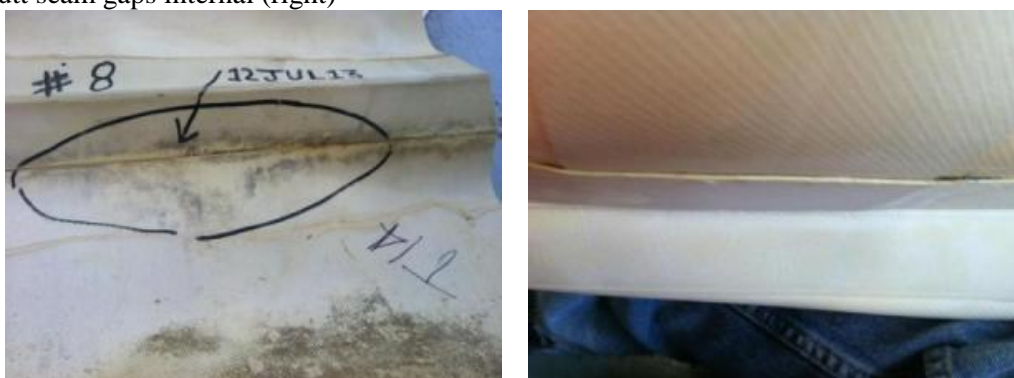
Figure 5.4.105 – Class I – T14-11 – Closing Seam – 18 SEP 13
Note wrinkles across weld throughout seam

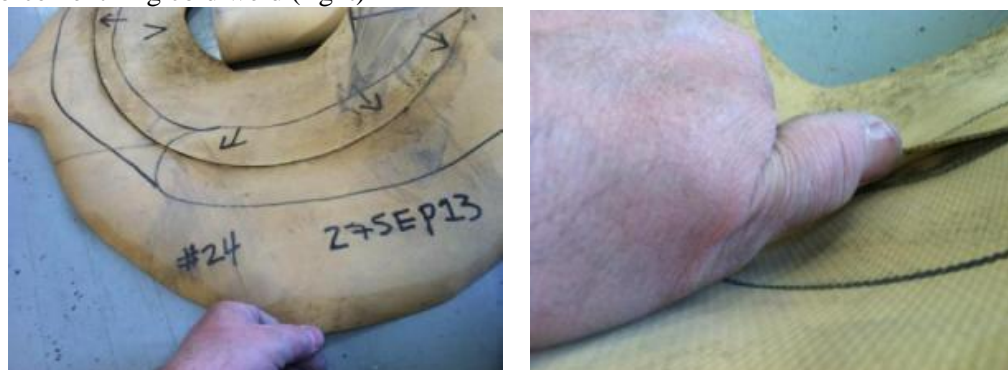
Figure 5.4.109 – Class I – T17-19,16,17 – Closing Seam – 3 JUL, 19 AUG, 17SEP 13
Gaps between material panels encased in adhesive – example of single internal root cause for multiple external “family” of leaks

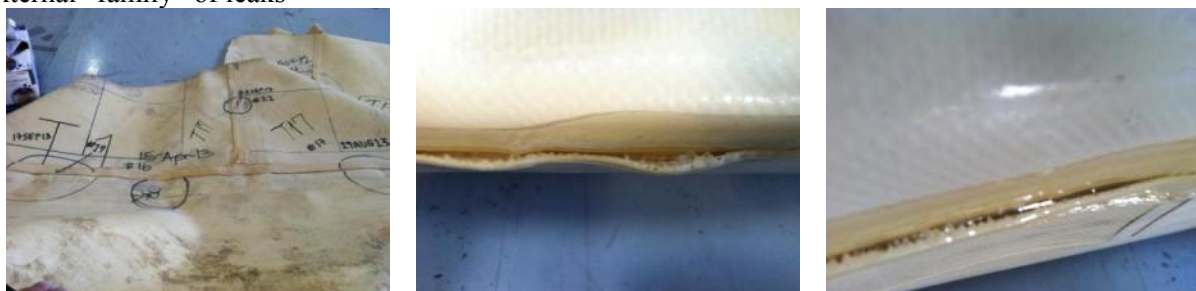
Figure 5.4.110 – Class I – T18-5 – Closing Seam – 28 AUG 12

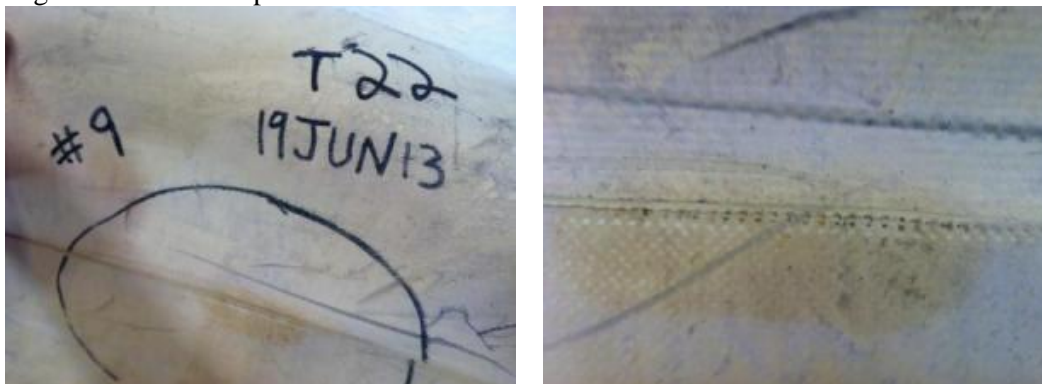
Figure 5.4.115 – No Leak Observed – T24 – Found during extraction
Major wrinkle in bottom of Tank 24 closing cross seam – no leak noted, however, impossible to see in field

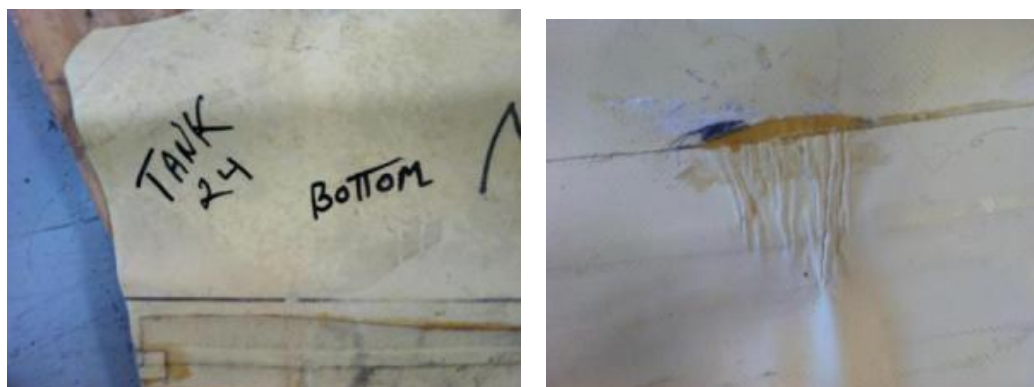
Figure 5.4.116 – Class I – T24-6 – T-Seam Closing – 27 NOV 12
Internal weld showing gaps and material puckering (left)

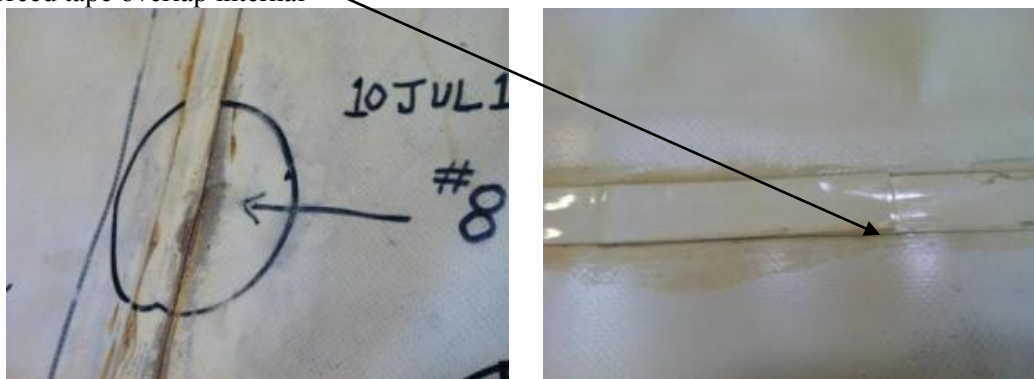
Figure 5.4.118 – T25 – No Leak – Found during extraction
Internal tape overstretch tear / gap

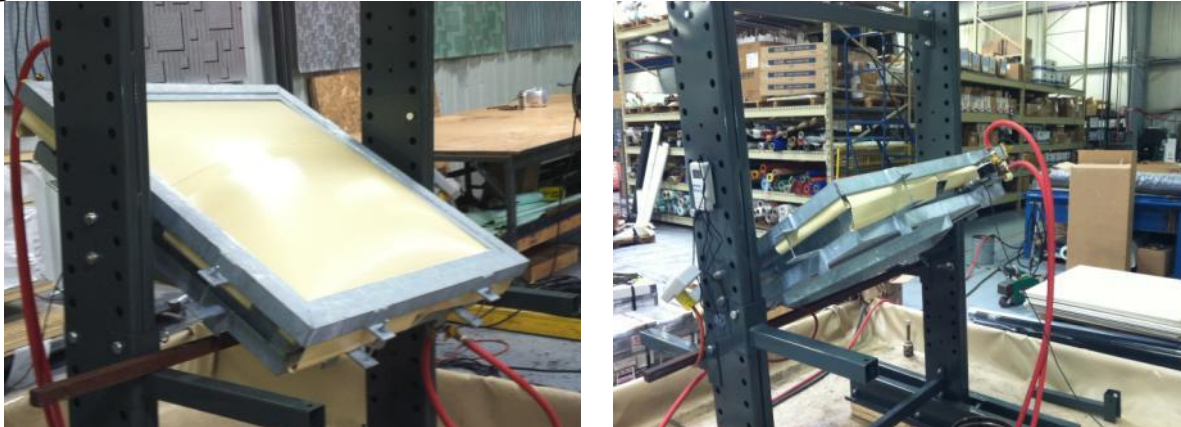
Figure 6.2.3 – LTR System Schematic

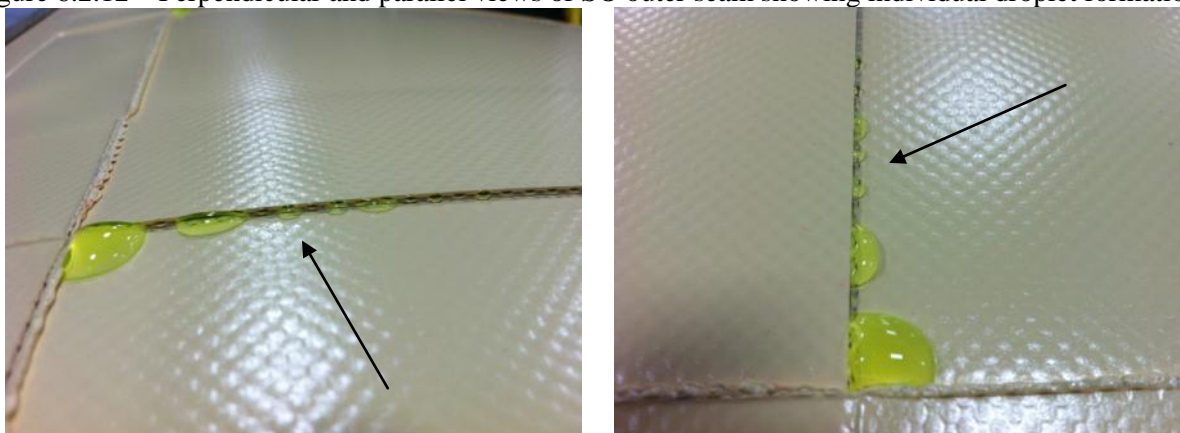
Figure 6.2.13 – Dye flow out of seam was greater at the beginning of second day once the system re-pressurized to ≥ 15 inches H_2O . The temperature was less than $90^{\circ}F$ at the start.

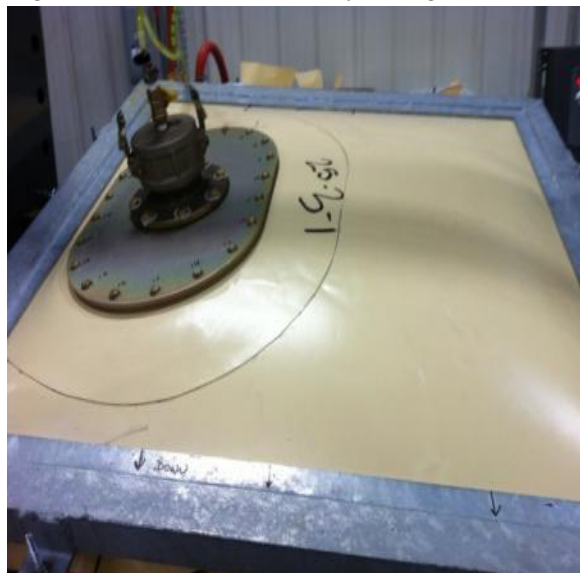
Figure 6.2.98 – Tank manway fitting close-up
